Technical Report HL-96-18
September 1996

Channel Stability Study, Flamingo Wash, Las Vegas, Nevada

by Ronald R. Copeland, Lisa C. Hubbard

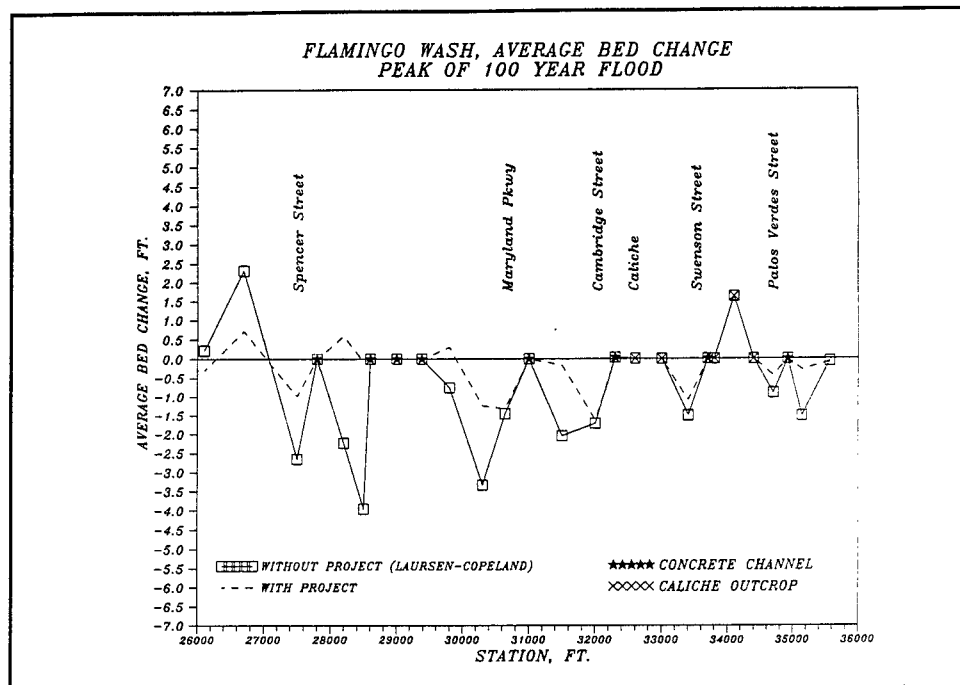
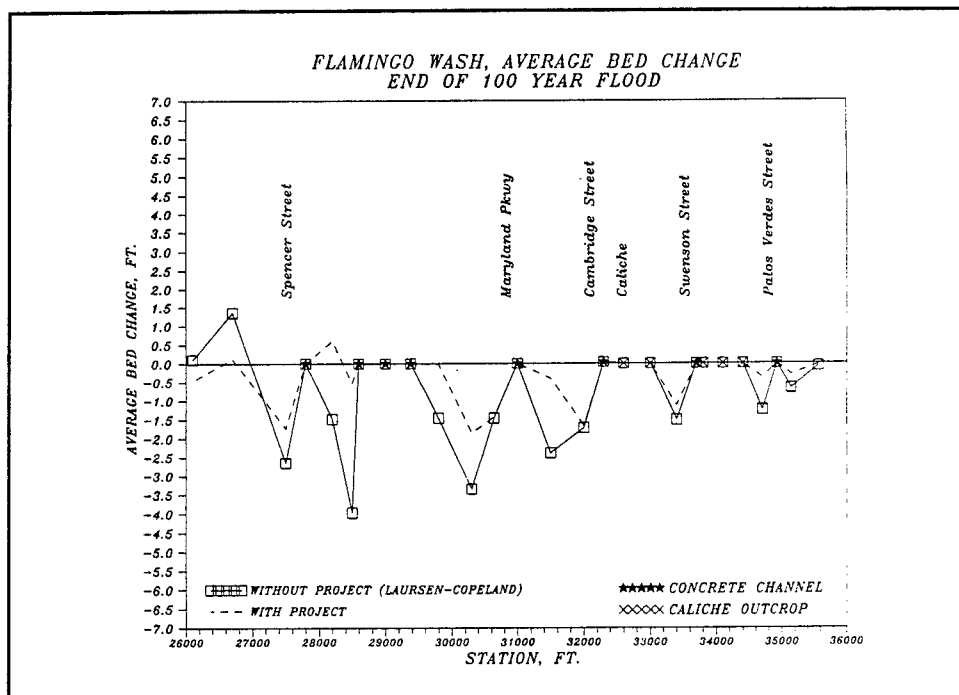
Figure 34. Calculated average bed changes, Flamingo Wash stations 260+00 to 358+00

Significant degradation was calculated on Flamingo Wash between Cambridge Street and Spencer Street. The bed elevation was maintained by concrete inverts at Maryland Parkway, Spencer Street, and through a short concrete-lined channel reach. Calculated degradation was significantly less for the with-project condition. A comparison of Figures 34a and b demonstrates that most of the degradation occurred by the time the peak flow occurred, and that little bed change occurred on the flood recession.

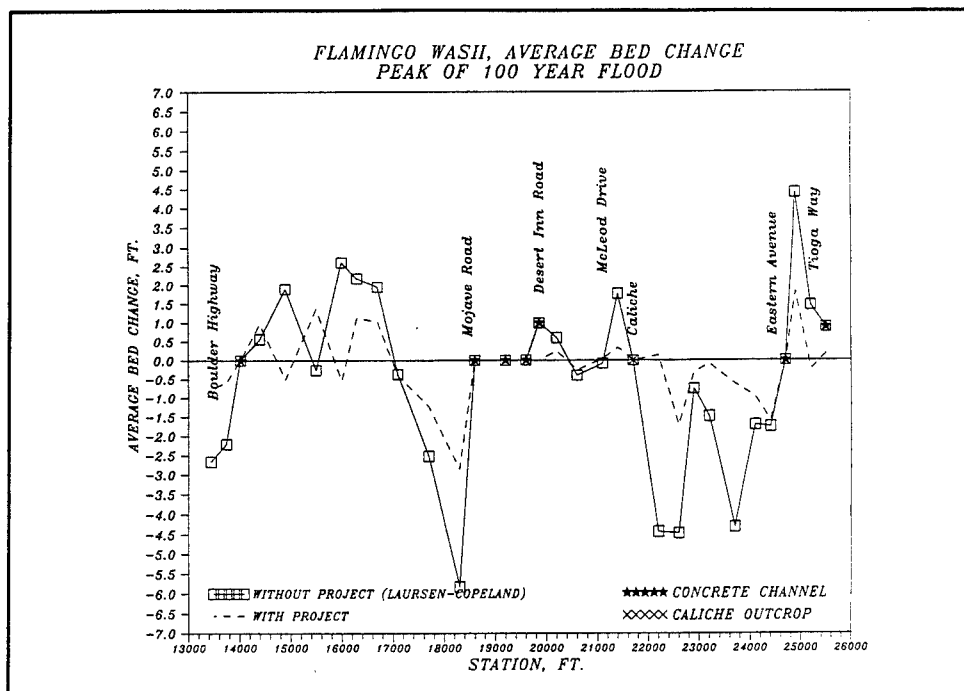
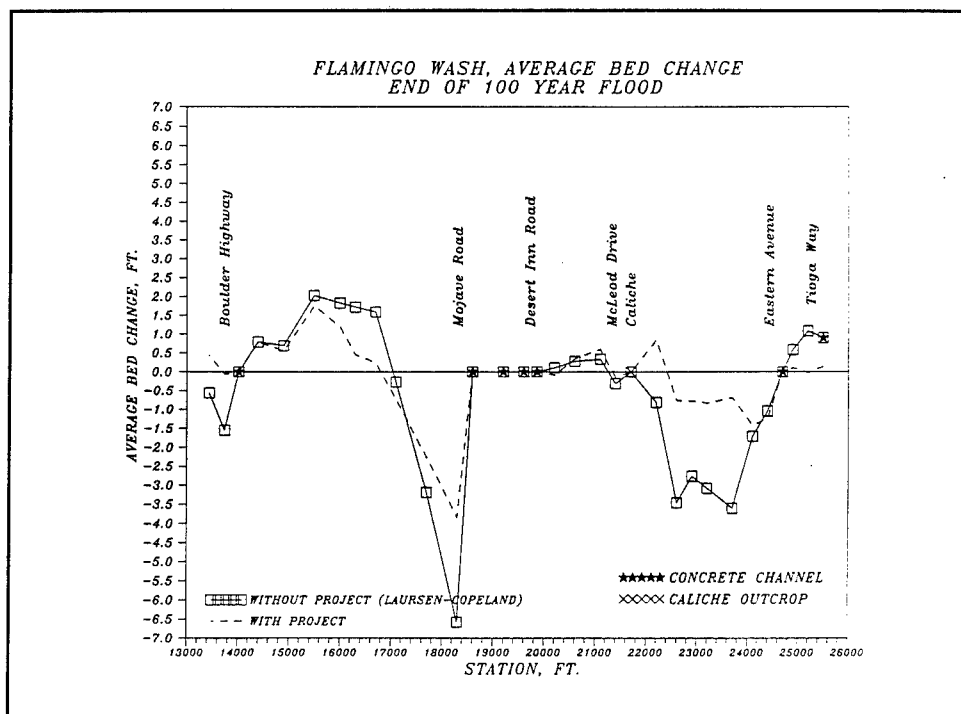
Figure 35. Calculated average bed changes, Flamingo Wash stations 130+00 to 260+00

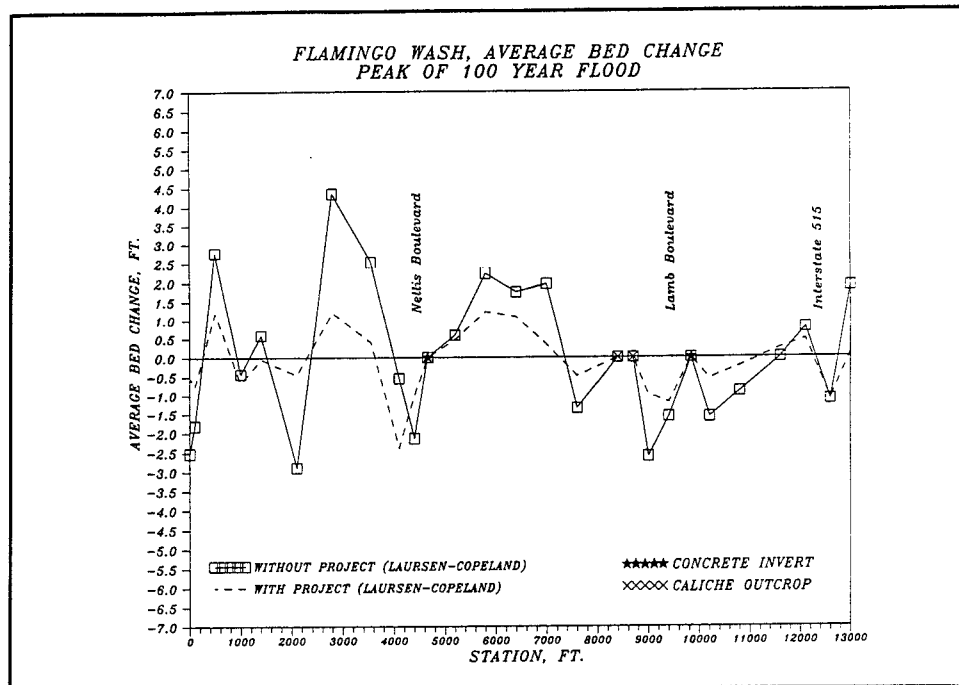
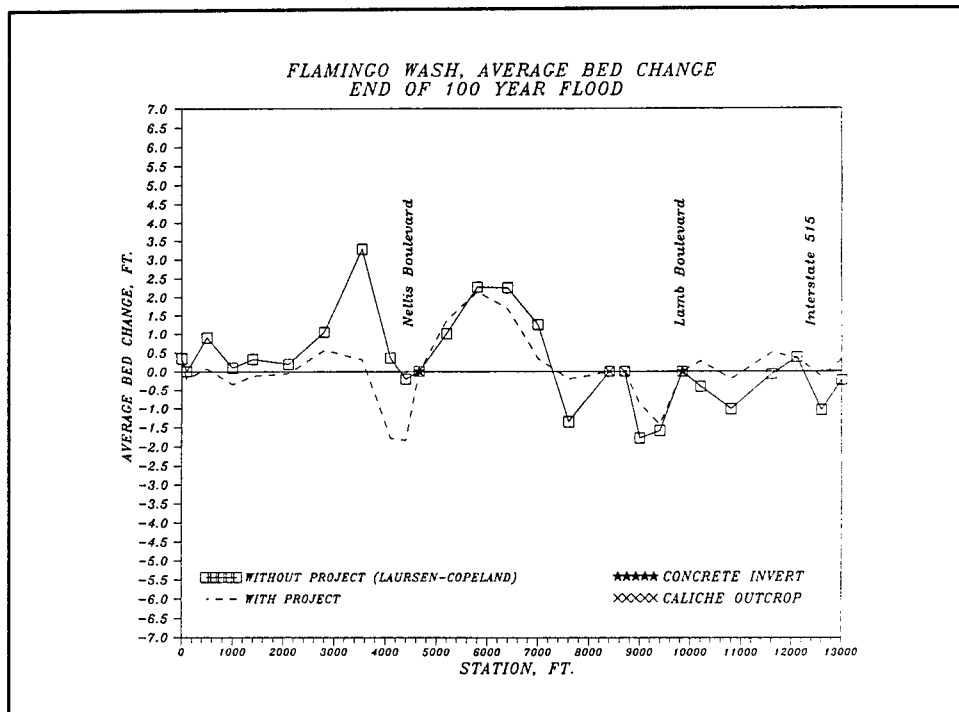
Figure 36. Calculated average bed changes, Flamingo Wash stations 0+00 to 130+00

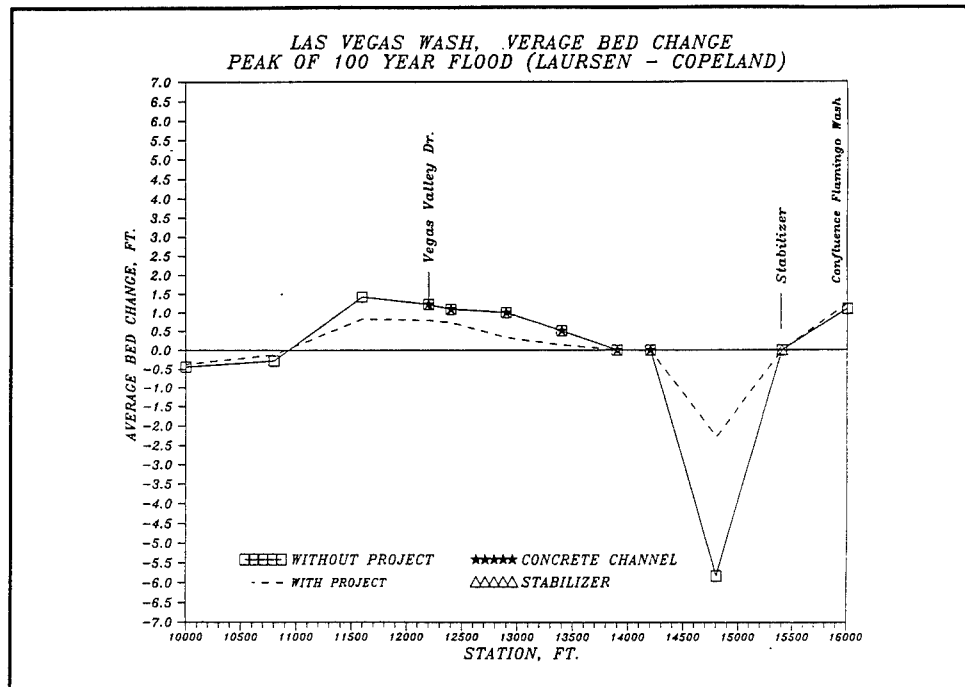
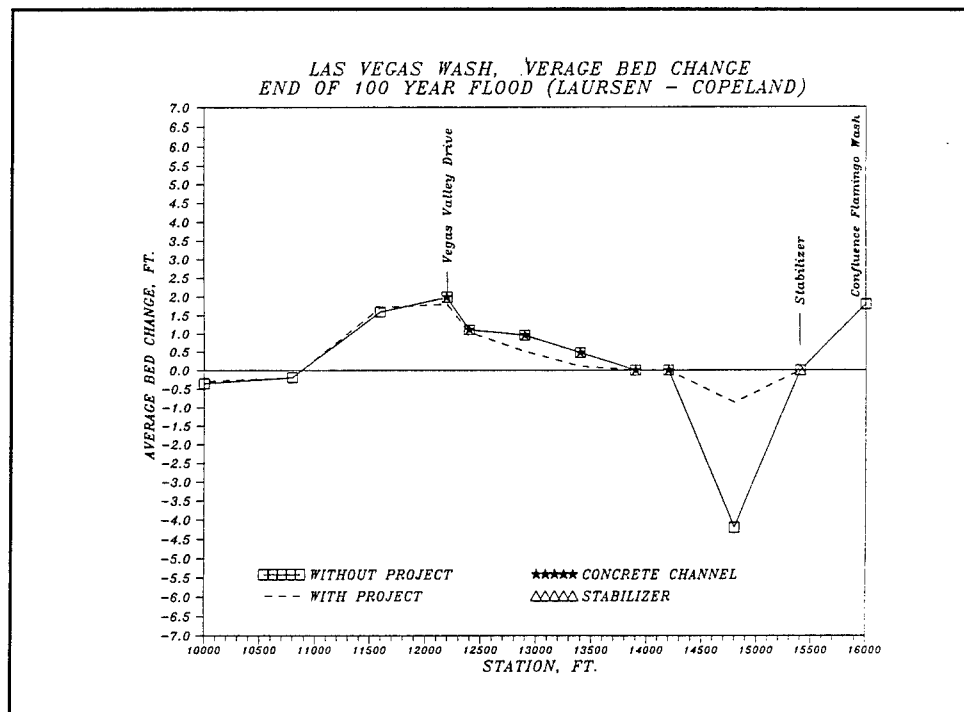
Figure 37. Calculated average bed changes, Las Vegas Wash stations 100+00 to 160+00

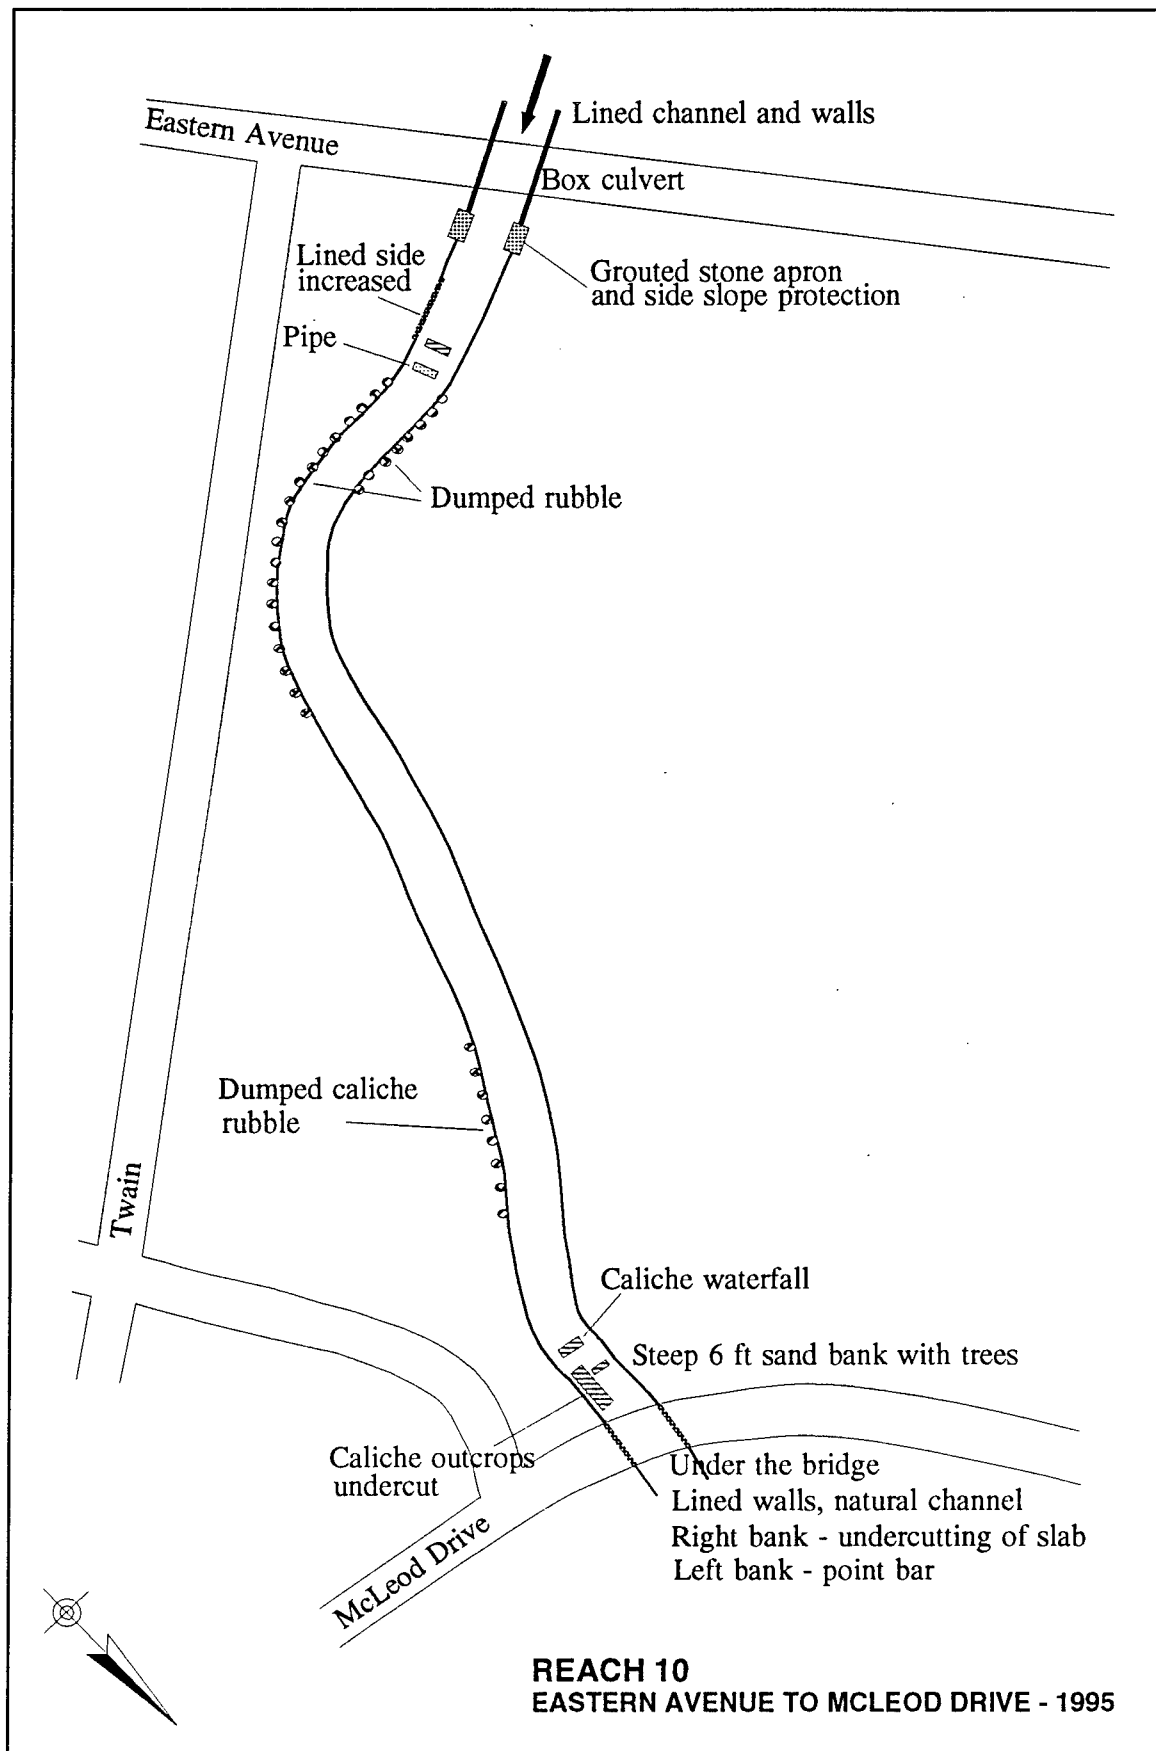
Plate 10

The bridge under McLeod Drive had concrete-lined side slopes and a natural invert. There was a gravel bar on the left bank, and undercutting of the slab on the right abutment was observed in August 1994. Evidence that repair work had occurred on the right abutment was observed. A plan view sketch of this reach is shown in Plate 10.
